UNDERWATER BRIDGE INSPECTION REPORT

STRUCTURE NO. 7137

WATSON SAG CHANNEL

MINNESOTA DEPARTMENT OF TRANSPORTATION
UNDERWATER BRIDGE INSPECTION

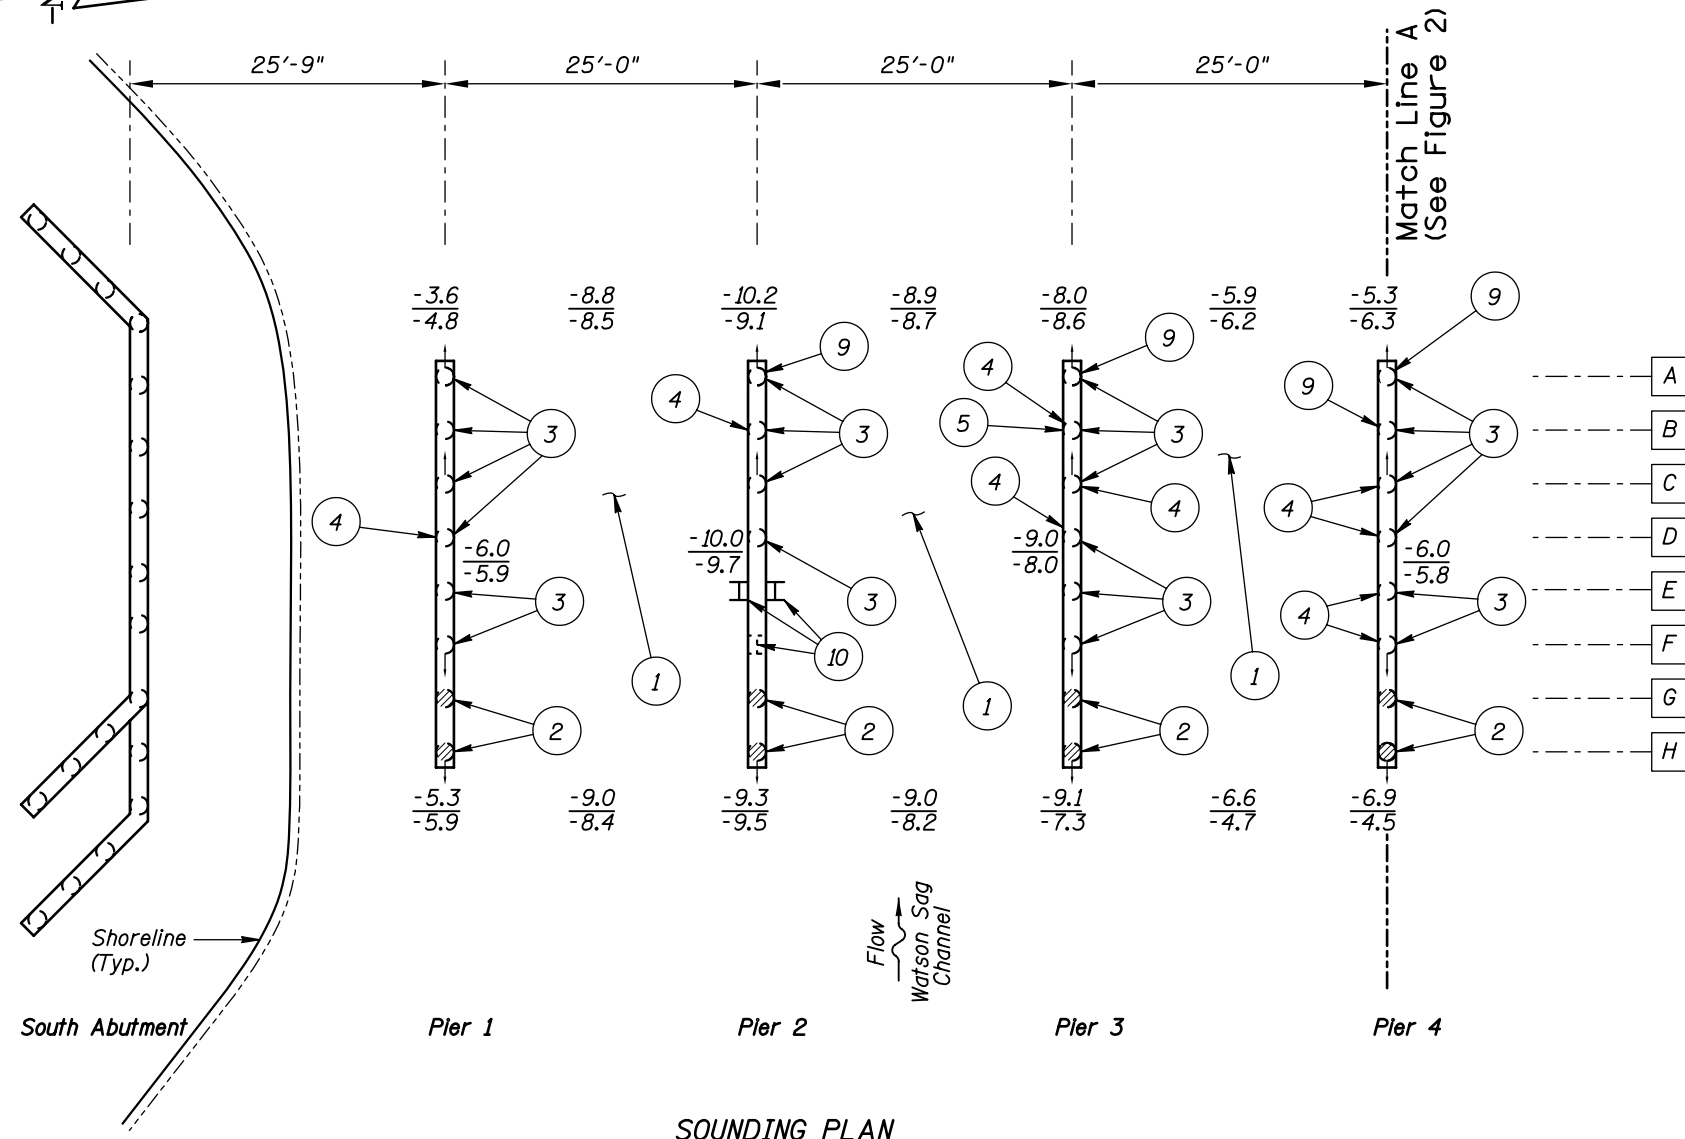
Drawn By: PRH	COLLINS ENGINEERS, INC.	Date: OCT. 2002
Checked By: MDK	300 W. WASHINGTON, STE. 600 CHICAGO, ILLINOIS 60606 (312) 704-9300	Scale: NTS
Code: 35120092		Figure No.: 1

- 1 The channel bottom material consisted of sandy silt and scattered 6 inch diameter riprap with up to 3 inches of probe rod penetration.
- 2 Light corrosion was observed on the steel piles from 3 feet above the waterline to the channel bottom with random minor pitting having a maximum penetration of 1/16 inch.

- 3 Minor splitting and checking of the timber piles was observed from the pier cap to the channel bottom with a maximum width of 1/4 inch and a maximum penetration of 1 inch.

- 4 Diagonal timber bracing was split through the fastener.
- 5 Abrasion damage observed on the timber pile, from 1.0 foot above the waterline to 2.5 feet below the waterline, approximately 8 inches wide with a maximum penetration of 0.5 inch.

- 6 Delamination on outer shell of timber pile was observed around the waterline with maximum penetration of 1/2 inch.
- 7 Split in pile, from the top of the pile cap to 8 feet above the waterline with a maximum width of 1/2 inch and 1 inch of penetration.

- 8 Split in pile, from the pile cap to 2 feet above the waterline with a maximum width of 3/4 inch and 2 to 3 inches of penetration.
- 9 Diagonal bracing broken and no longer attached to pile.

- 10 Piles E and F at Pier 2 were replaced with three steel H-Piles connected with steel bracing.

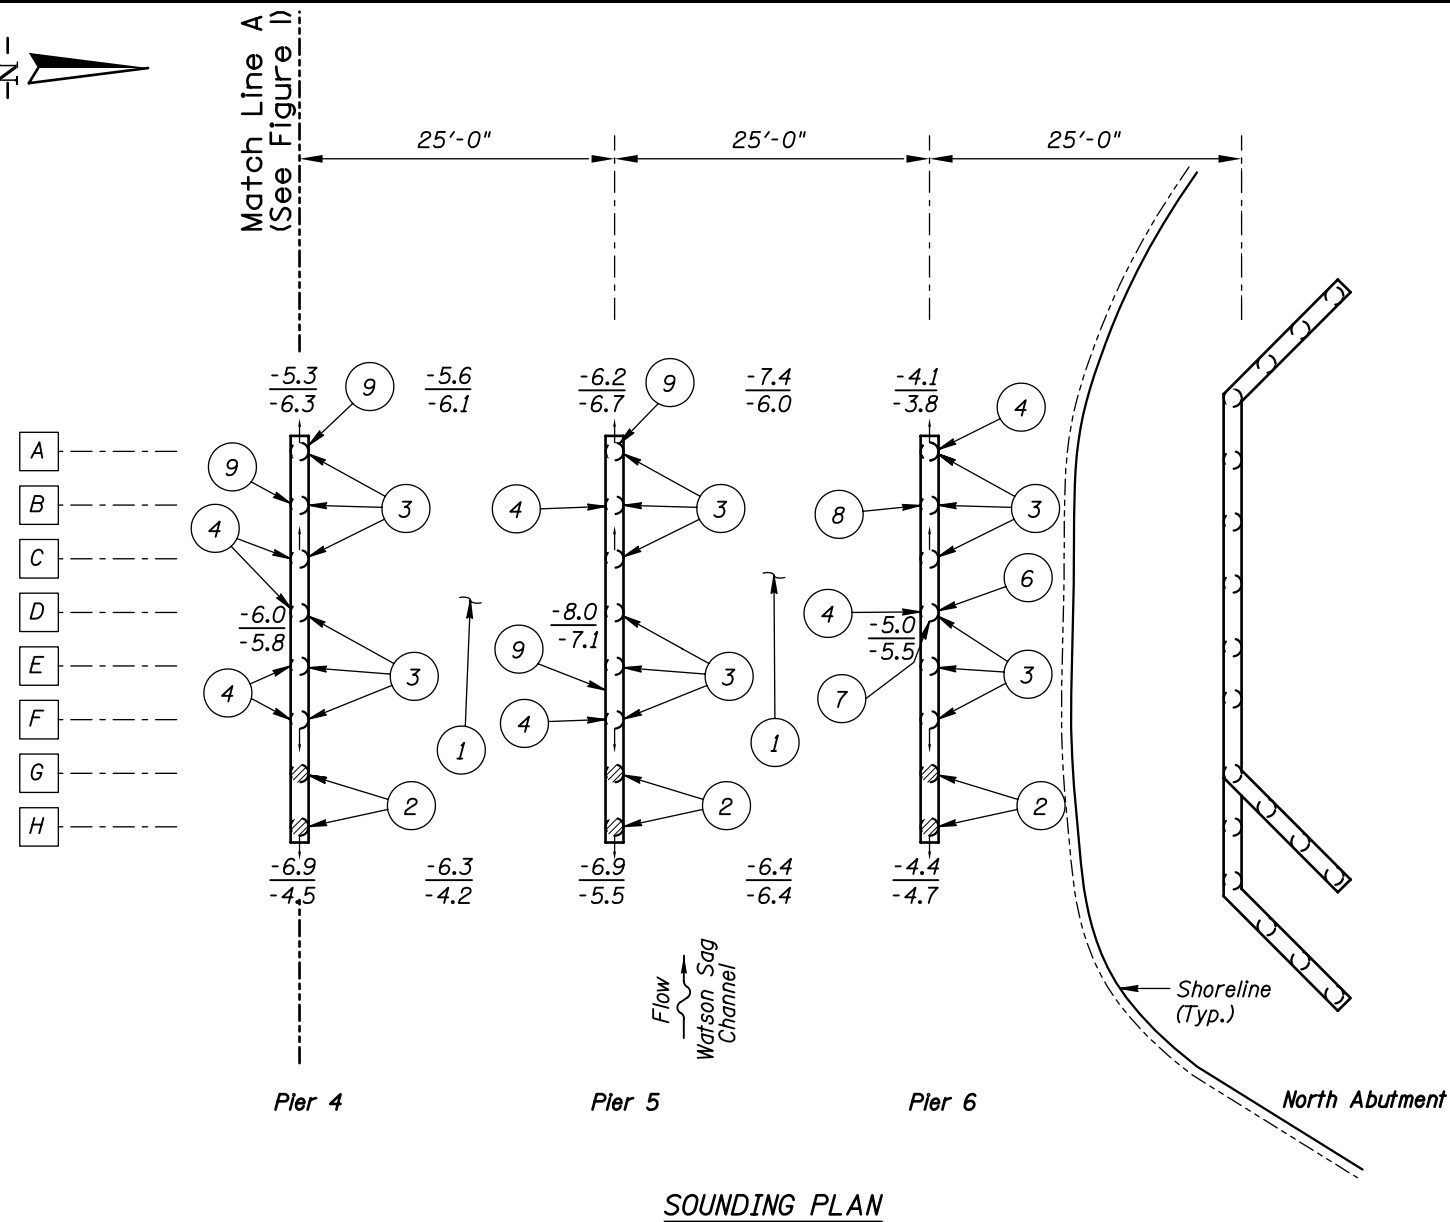
Date: OCT. 2002
Scale: NTS
Figure No.: 2

- 1 The channel bottom material consisted of sandy silt and scattered 6 inch diameter riprap with up to 3 inches of probe rod penetration.
- 2 Light corrosion was observed on the steel piles from 3 feet above the waterline to the channel bottom with random minor pitting having a maximum penetration of 1/16 inch.

- 3 Minor splitting and checking of the timber piles was observed from the pier cap to the channel bottom with a maximum width of 1/4 inch and a maximum penetration of 1 inch.

- 4 Diagonal timber bracing was split through the fastener.
- 5 Abrasion damage observed on the timber pile, from 1.0 foot above the waterline to 2.5 feet below the waterline, approximately 8 inches wide with a maximum penetration of 0.5 inch.

- 6 Delamination on outer shell of timber pile was observed around the waterline with maximum penetration of 1/2 inch.
- 7 Split in pile, from the top of the pile cap to 8 feet above the waterline with a maximum width of 1/2 inch and 1 inch of penetration.

- 8 Split in pile, from the pile cap to 2 feet above the waterline with a maximum width of 3/4 inch and 2 to 3 inches of penetration.
- 9 Diagonal bracing broken and no longer attached to pile.

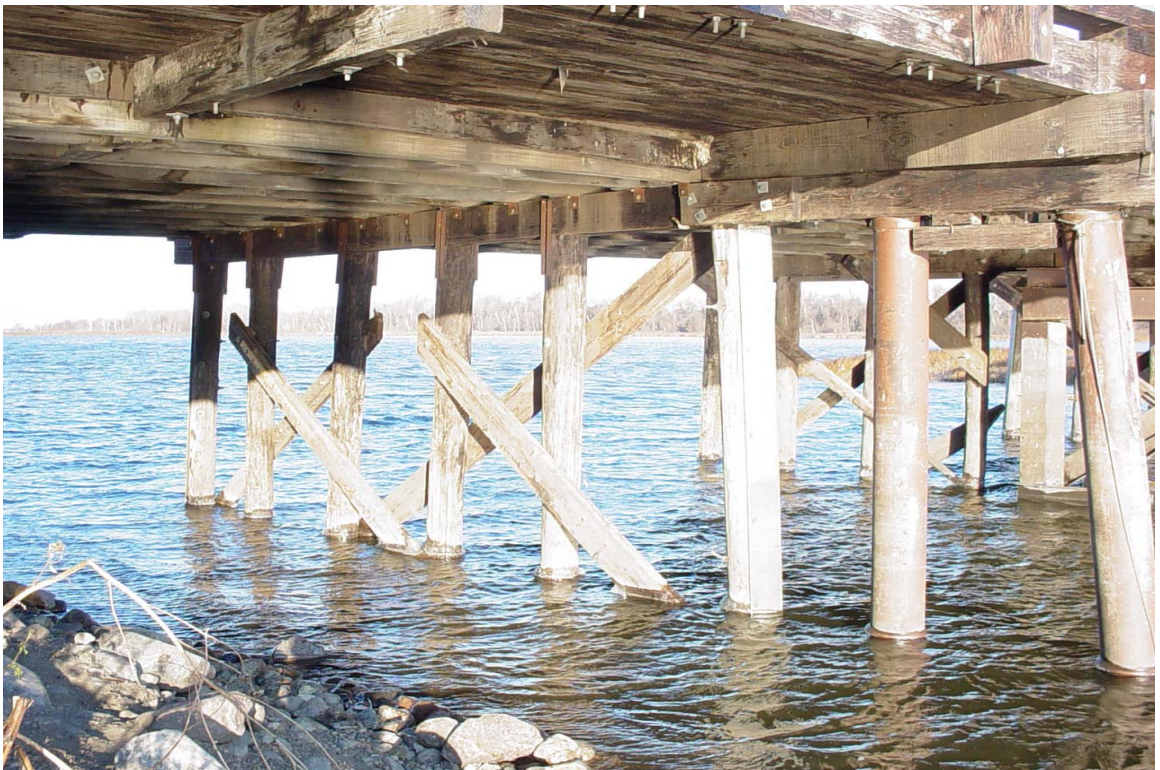
Photograph 2. View of Pier 1, Looking Northwest.

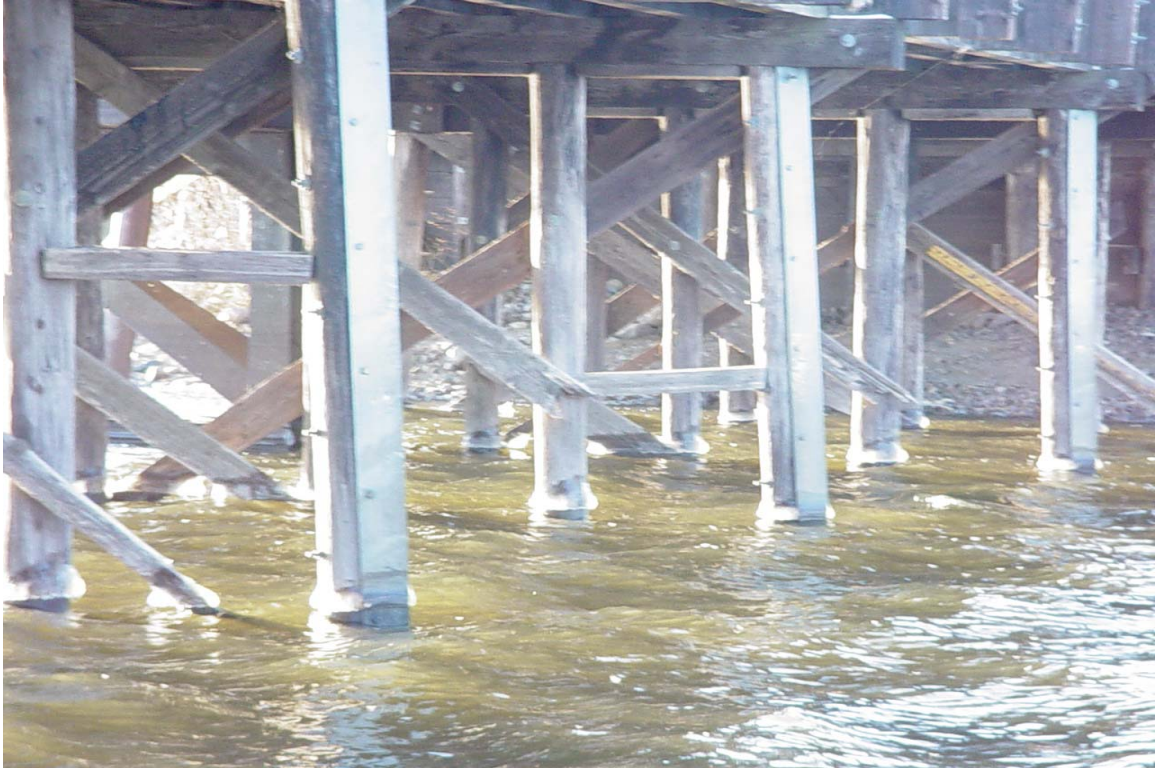
Photograph 3. View of Upstream End of Piers 2, 3, and 4, Looking Southeast.

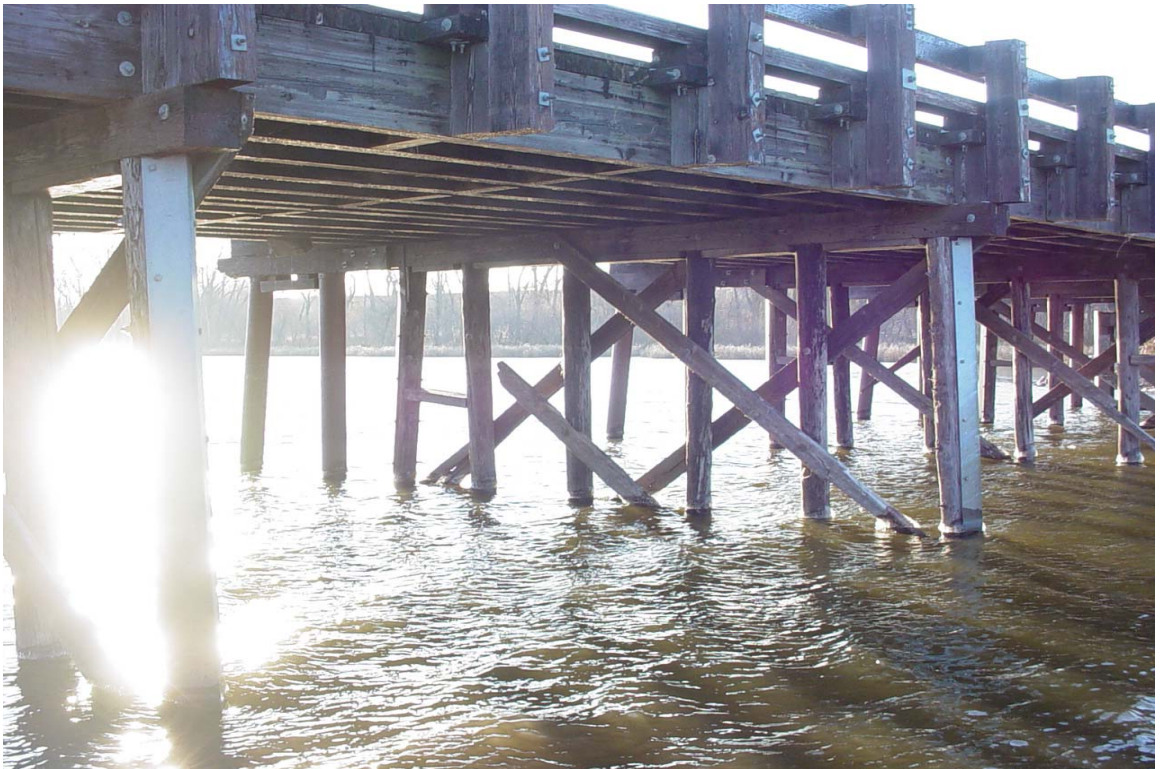
Photograph 4. View of Pier 5, Looking Southeast.

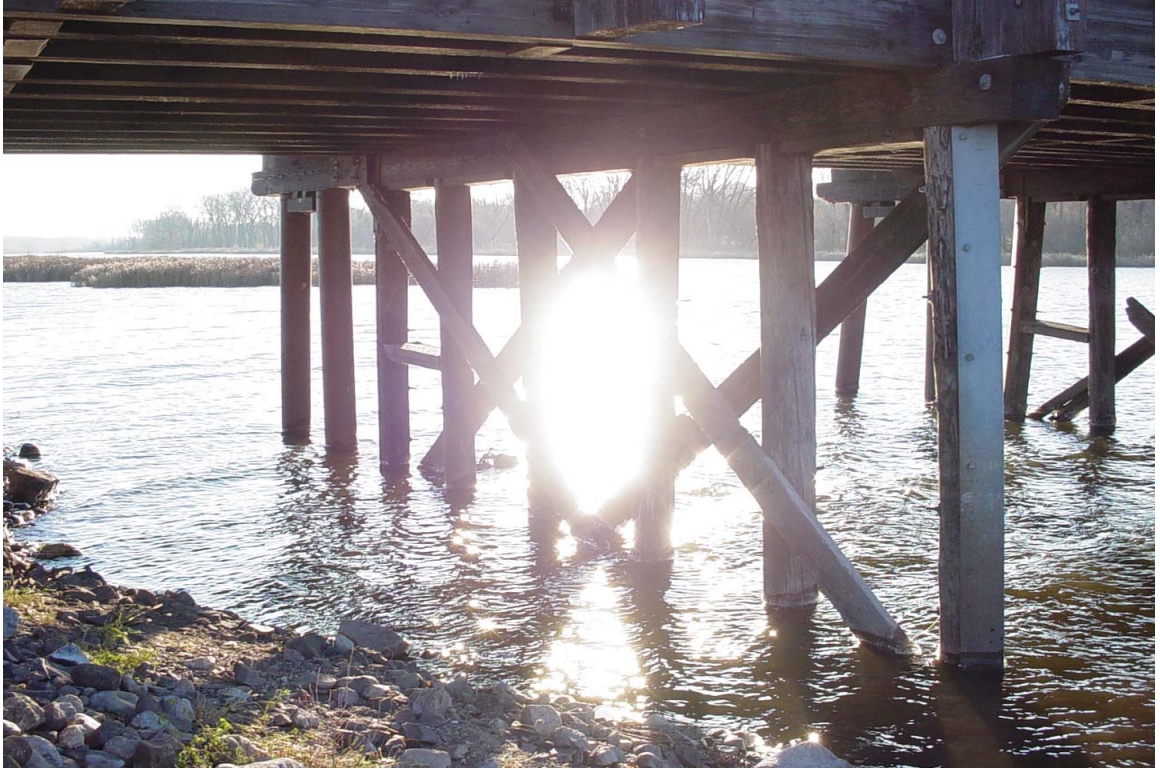
- (D) Two piles were split above the waterline at Pier 6. Pile B was split from the top of the pile to 2 feet above the waterline with a maximum width of 3/4 inch and up to 3 inches of penetration. Pile D was split from the top of the pile to 8 feet above the waterline with a maximum width of 1/2 inch and up to 1 inch of penetration.

Photograph 5. View of Pier 6, Looking Southeast.
